ANNUAL ENVIRONMENT REPORT 2011

This is the Annual Environmental Report for the year ended 31 December 2011 for the Hidden Valley Gold Mine (HVGM), submitted by Hidden Valley Services Limited (HVSL) as holder of Environmental Permit WD L3(50).

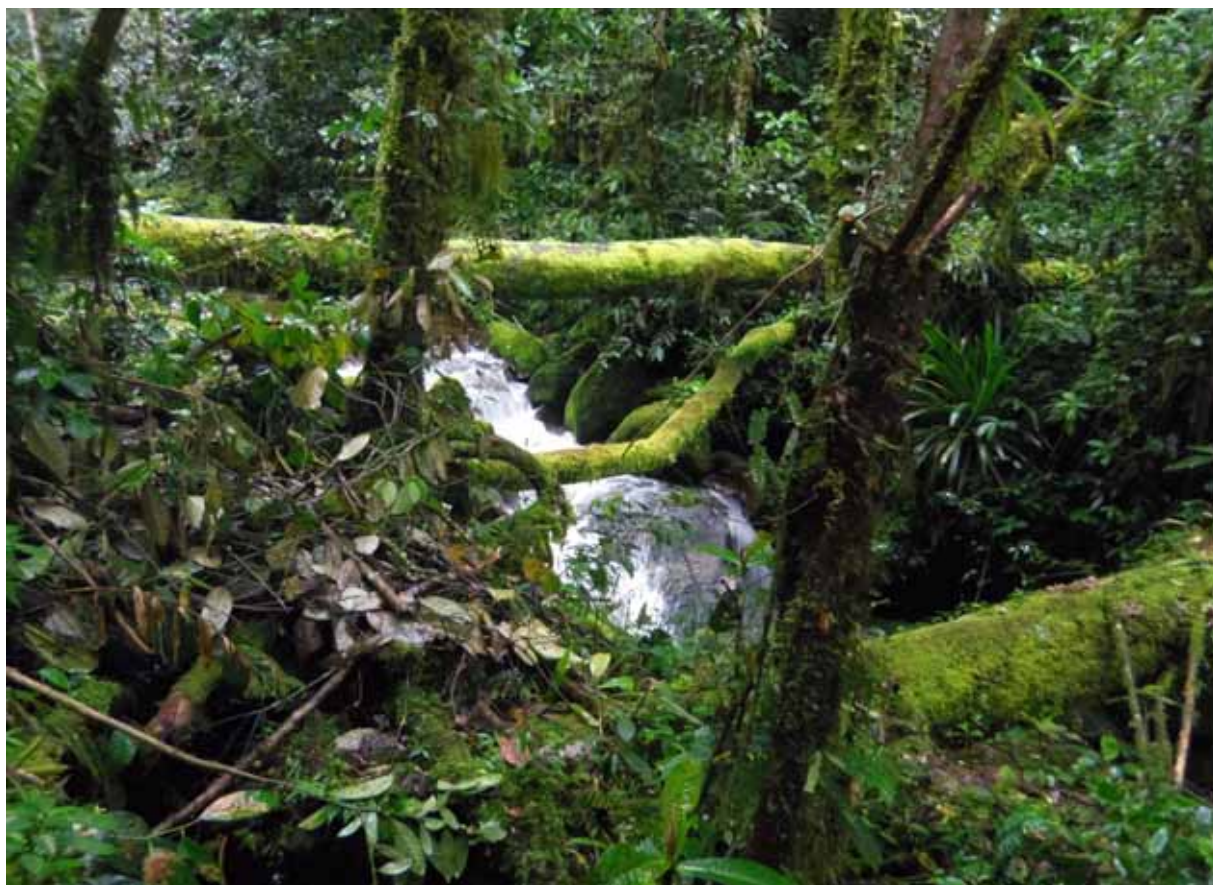
Figure 1: Mountain Stream near Hidden Valley Gold Mine

HVGM is located at elevations above 1,900 m and within steep mountainous and forested terrain that experiences about 3 m of rainfall per year. Features include narrow streambeds, sharp ridges, and V shaped valleys with grades exceeding 30° (refer Figure 1). Some seismic activity has been recorded and an earthquake exceeding magnitude 7.0 on the Richter scale was experienced in November 2011.

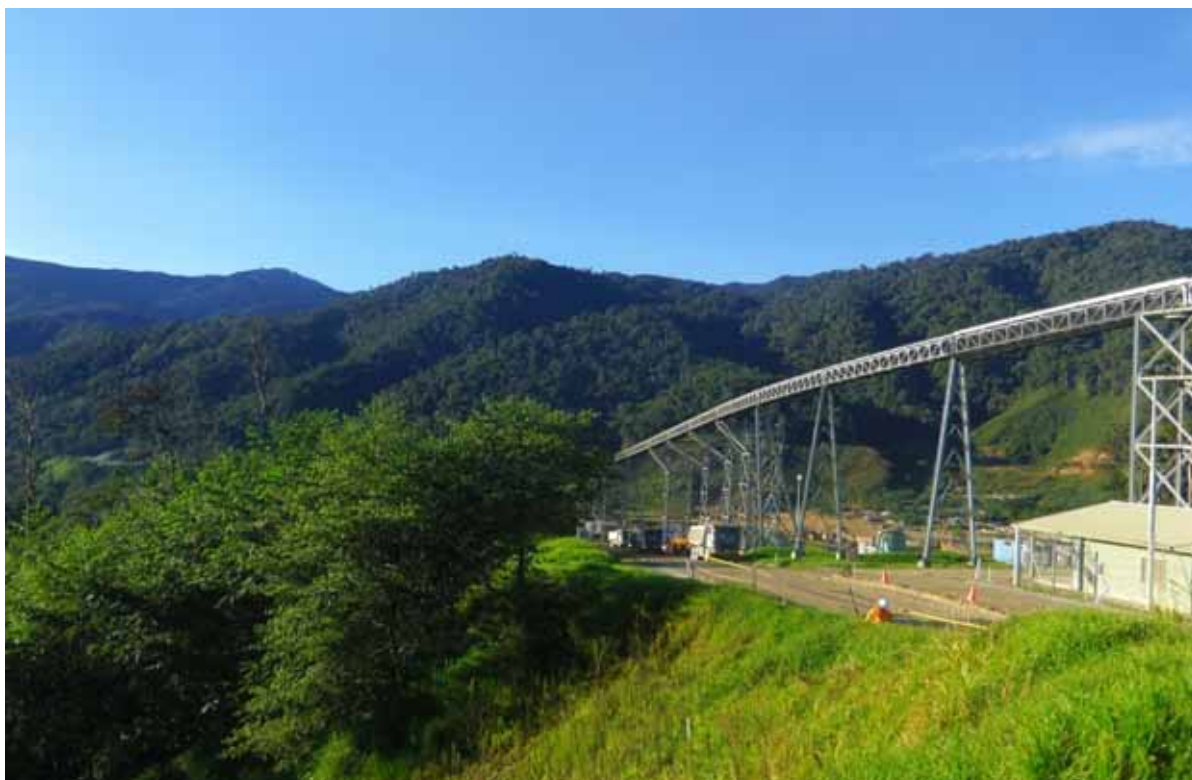
Figure 5: Hidden Valley Ore Conveyor

The HVK pit is approximately 5 km from the process plant and ore is transported from this pit to the plant by an overland conveyor (refer Figure 5). Tailings are deposited as slurry into the Tailings Storage Facility (TSF) adjacent to the plant and reclaimed water is either used in the process plant or treated in a Cyanide Detoxification Plant (CDP) before release into Pihema Creek.

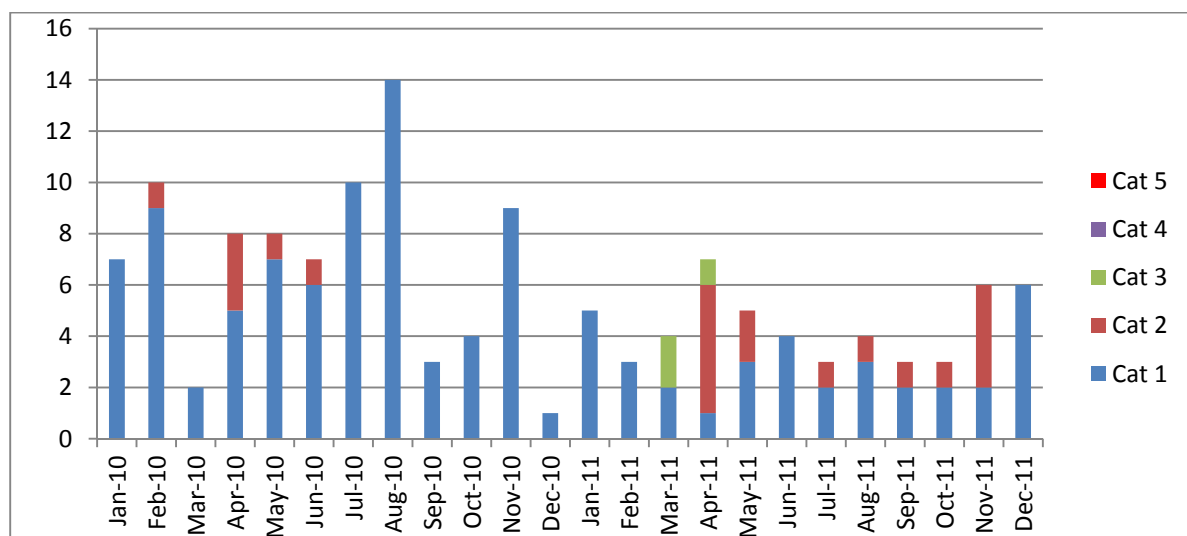
Figure 6: Environmental Incidents in 2010 and 2011

The 53 reported incidents in 2011 was a lower incidence than the 83 reported in 2010 (refer Figure 6) but the overall pattern was similar with most relating to minor spills of hydrocarbons and process chemicals.

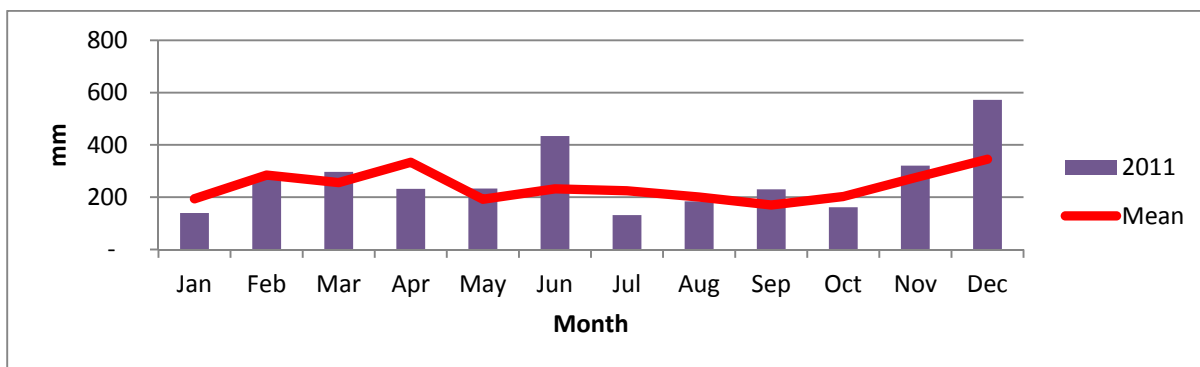
Figure 12: 2011 Ridgeline AWS Rainfall and Long Term Mean

A total 3,211 mm of rain was recorded at the ridgeline AWS (communication tower) in 2011 and included an exceptionally wet December which experienced 580 mm of rainfall which was 200 mm above average (refer Figure 12).

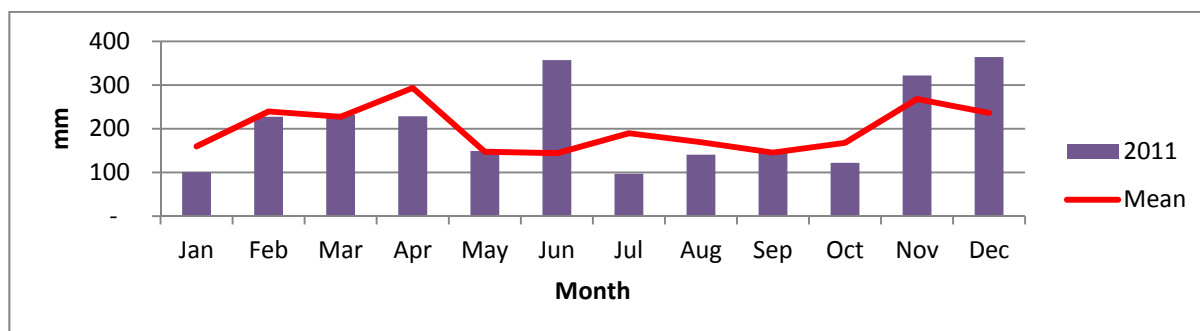
Figure 13: Rainfall at Hamata AWS 2011 and Long Term Mean

Hamata recorded a total of 2,486 mm in 2011 compared to the long term mean of 2,388 mm (refer Figure 13).

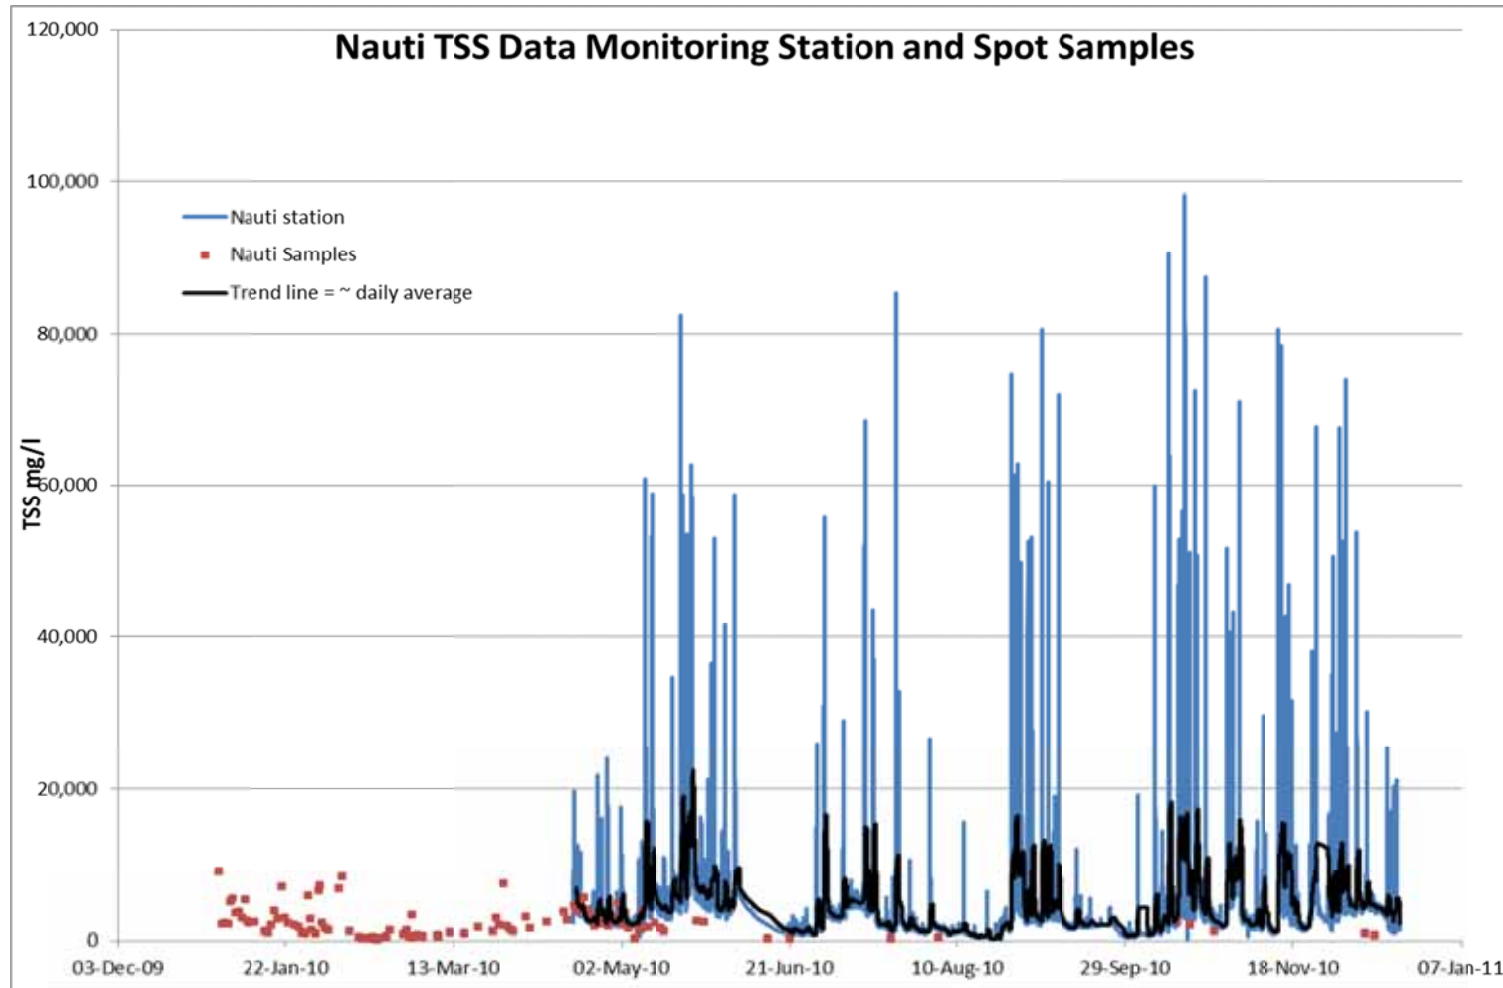
Figure 14: Water Monitoring Station and Spot Sampling TSS Data at Nauti in 2010

the year. The average sediment load at Nauti in 2010 based on 63,000 readings was 4,732 mg/L compared to 4,239 mg/L in 2011 based on 89,000 readings (refer Table 8) . The highest result in 2010 was close to 100,000 mg/L and 80,000 mg/L in 2011 (refer Figures 14 and 15).

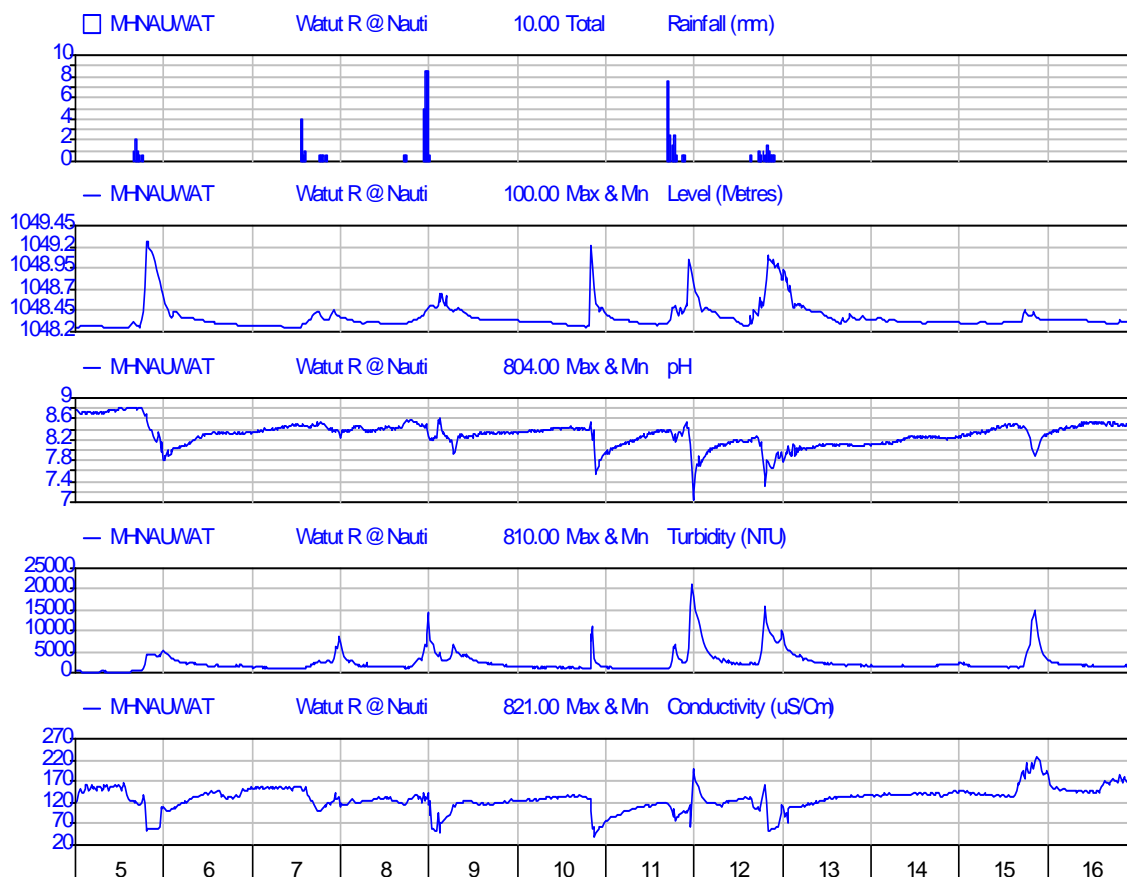
Figure 20: Nauti Monitoring Station Data (example plot 5 to 16 February 2011)

Dissolved manganese is currently a metal of concern in the ARD because it was at times elevated at Nauti during 2011. The pattern of falling pH at Nauti under rising river conditions indicate that ARD is flushed from the upper surface of the waste dumps during storm events resulting in a pulse of metals which elevates concentrations at Nauti, despite dilution from the increased river flows (refer Figure 20). It is important therefore to attenuate the ARD at source and lime will be added to South Dump to assess the effectiveness of direct lime dosing to enable the scoping of a more comprehensive program.

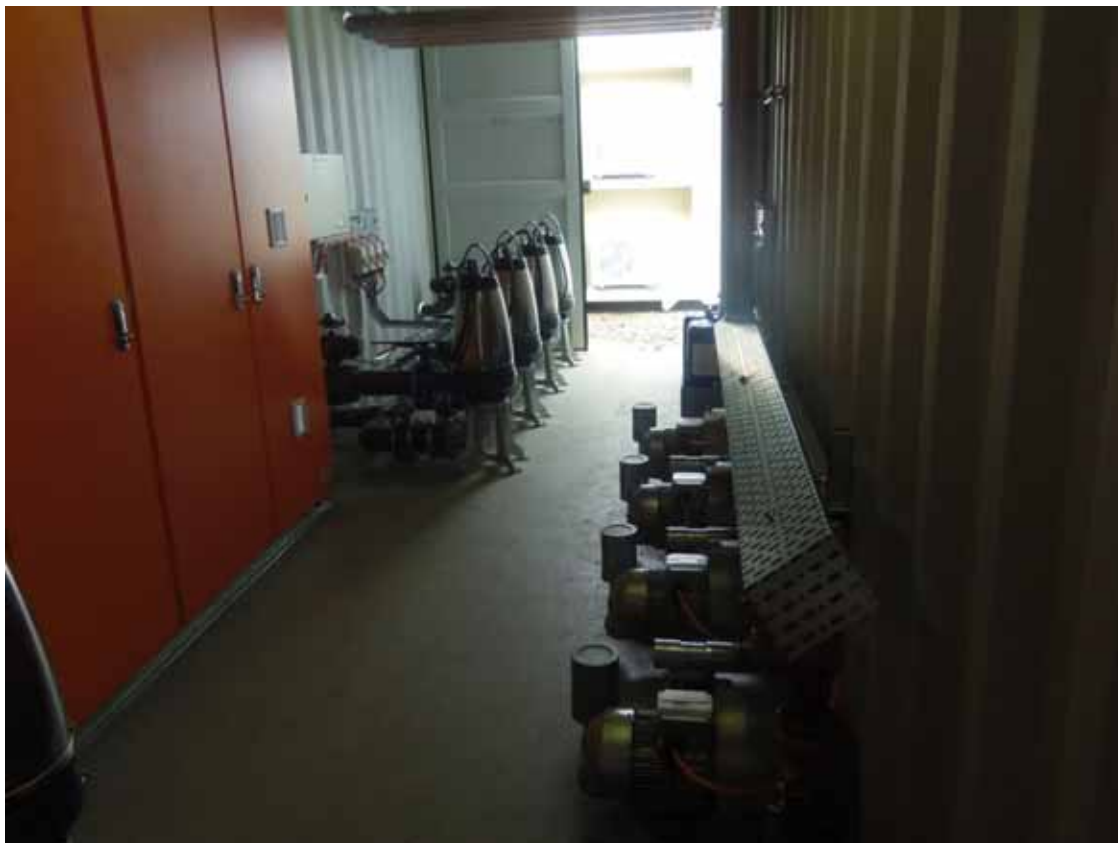
Figure 21: Hidden Valley High Capacity Sewage Treatment Plant December 2011

The commissioning of a new high capacity STP on the ridgeline in December 2011 addressed a significant problem area as the previous STP lacked the capacity to effectively treat sewage generated by the 1,500 person work-force (refer Figure 21).

The ridgeline Sewage Treatment Plant (STP) originally constructed at HVGM was found to be under-sized for the large work-force. This was resolved at the end of 2011 with the commissioning of a new high capacity STP expected to be fully commissioned in Quarter 1 2012.

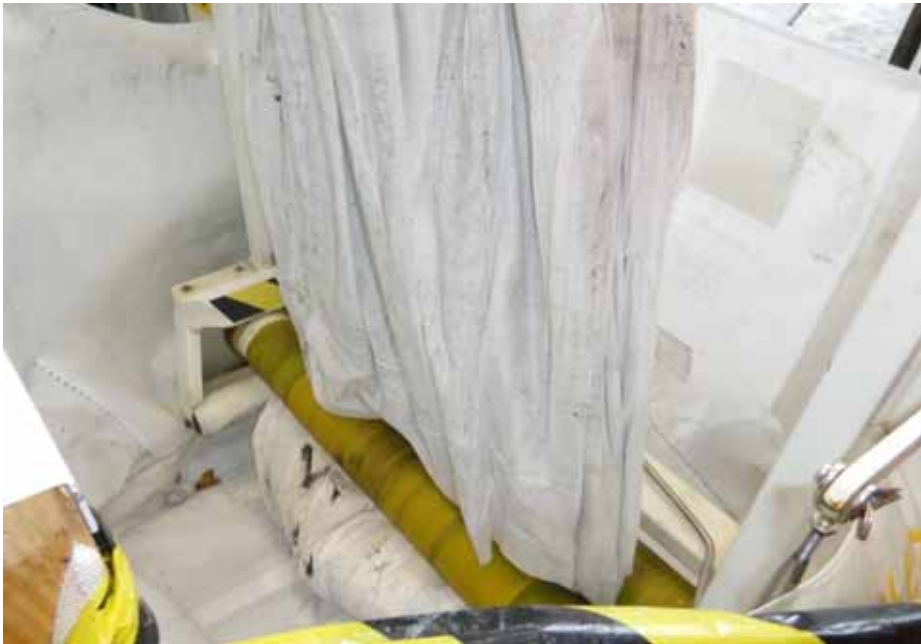
Figure 22: Grease Bags Used to Reduce Waste and Eliminate Drums

- Purchasing grease in plastic bags which can be rolled to remove almost all grease and thereby reducing the production of oily waste and of waste grease drums (refer Figure 22).
- Routine tracking of waste streams to enable the development of improvement targets.
- Establishment of a lime pit to neutralise battery acid and facilitate the recycling of waste batteries.

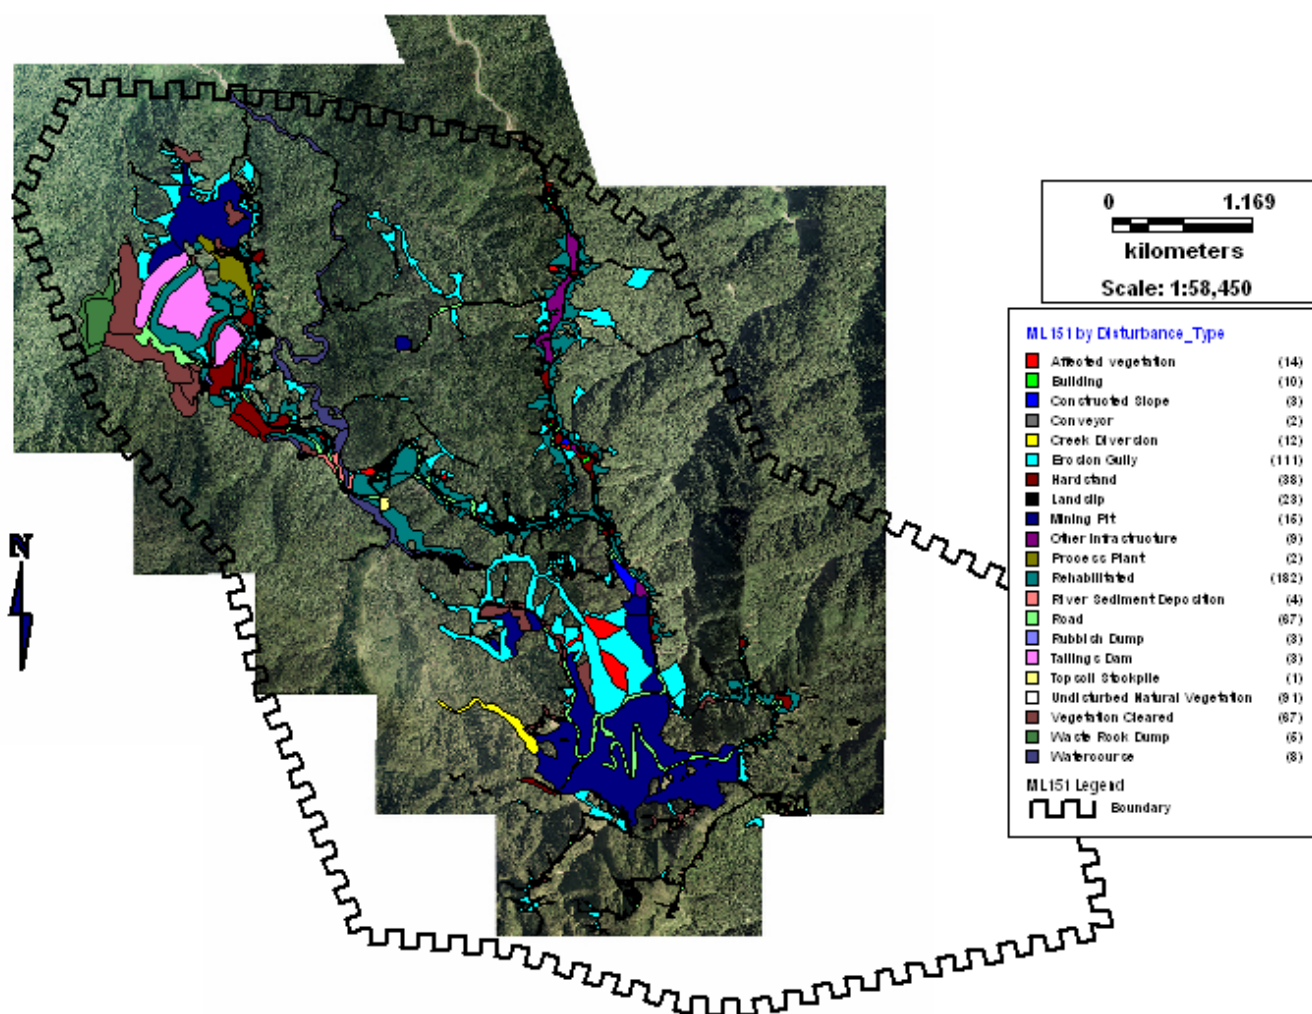
Figure 23: Land Disturbance Map

HIDDEN VALLEY ML151 LAND DISTURBANCE TYPES
